# Inspection Report

## EMH Home Inspections

<b>Date:</b> 7/15/2019	<b>Time:</b> 10:00 AM	<b>Report ID:</b>
<b>Property:</b>	<b>Customer:</b> Mr. John Doe	<b>Real Estate Professional:</b>

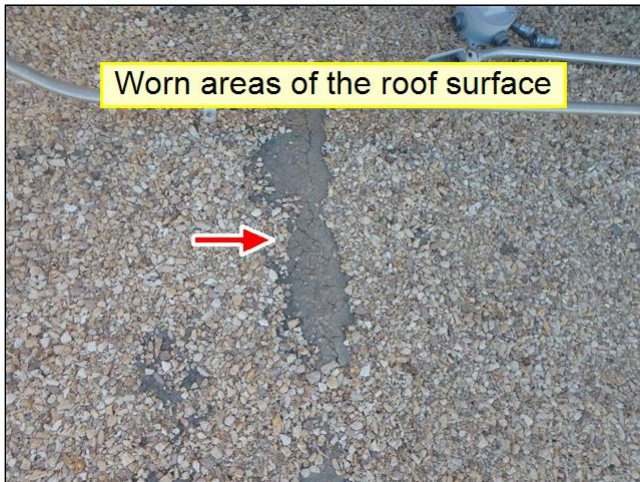
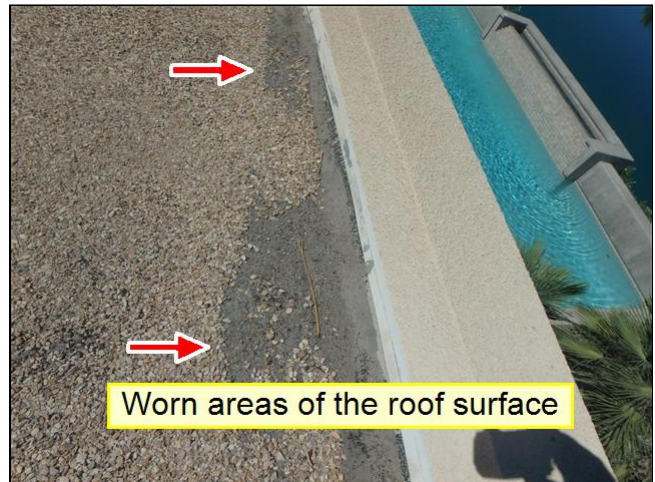
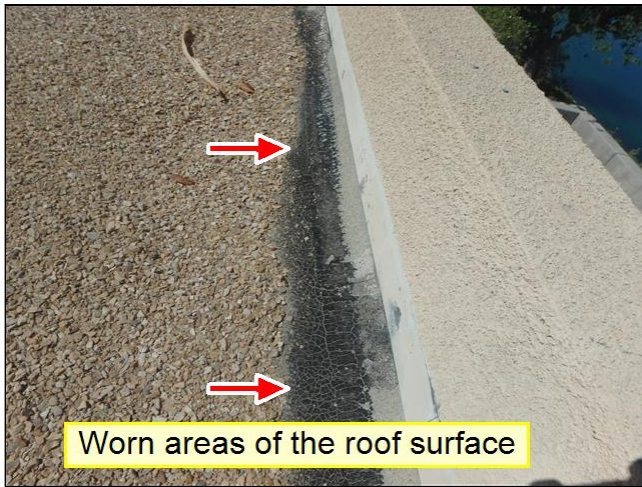
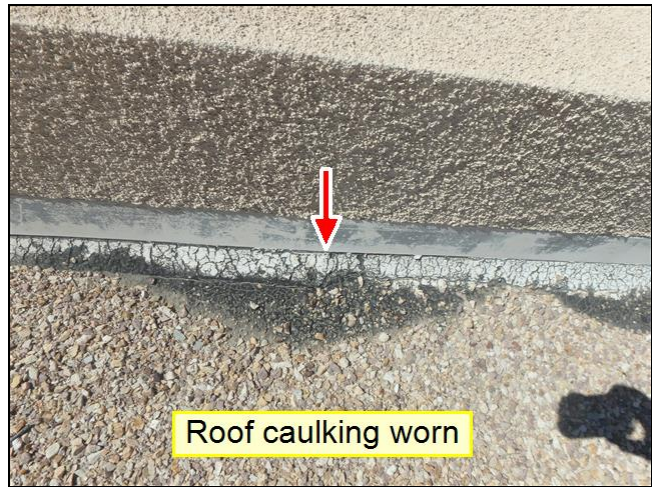
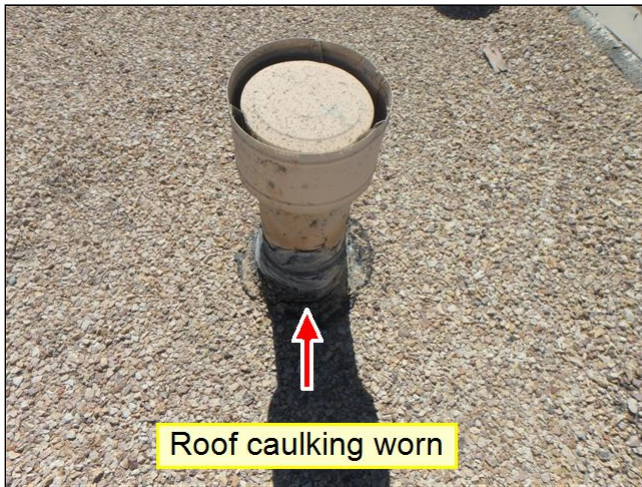
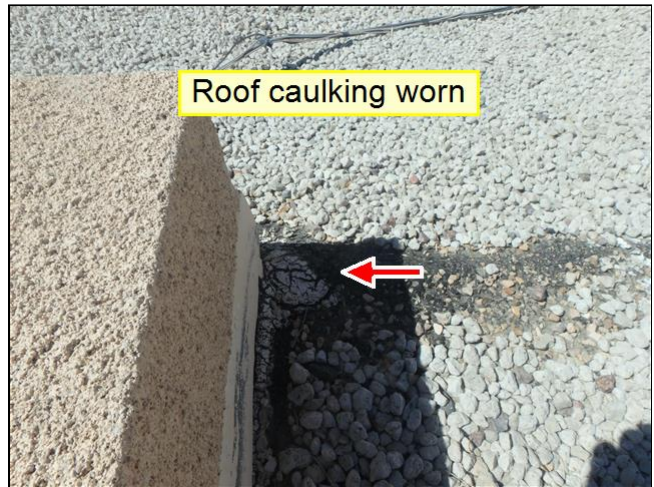
Roof appears to be in functional condition. The Asphalt roof surface is showing age with worn areas. The age of the roof surface could not be determined. The roof penetrations caulking is worn. Recommend further evaluation with a Roofing contractor for repairs.

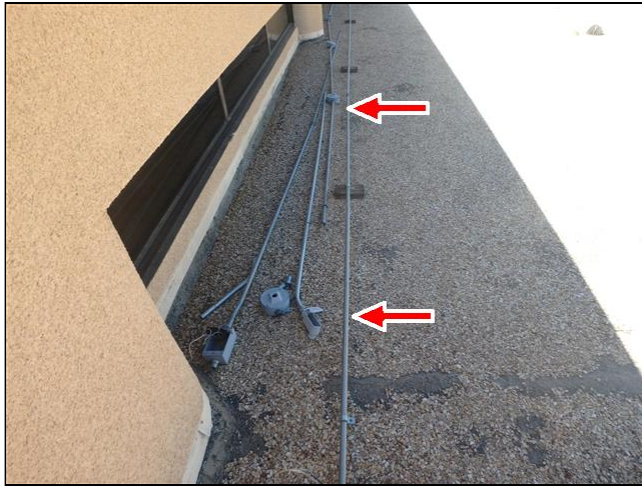
3.4 Item 1(Picture)

There is abandoned electrical conduits on the roof. Recommend removal.

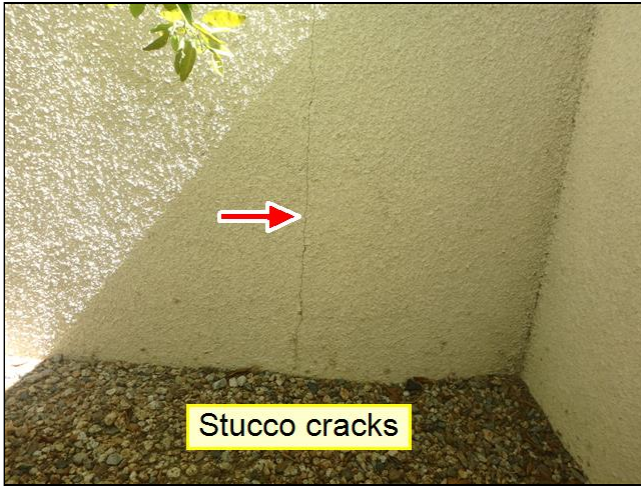
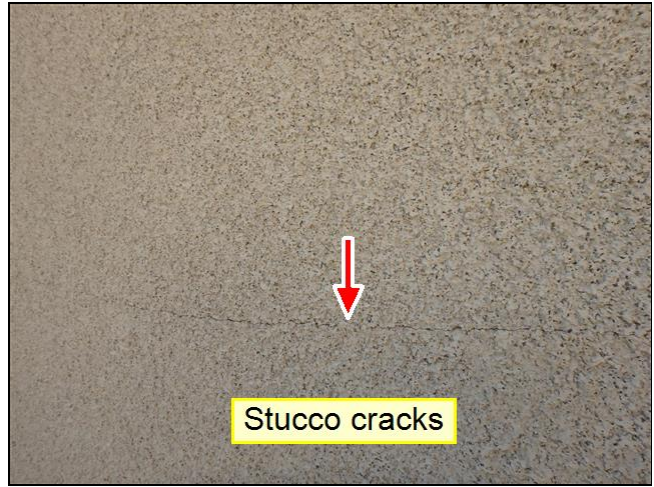
The stucco surface for the home has some cracking and chipping. This is consistent with this type of siding material for this region. Recommend checking on an annual basis and sealing any areas larger than an eighth inch.

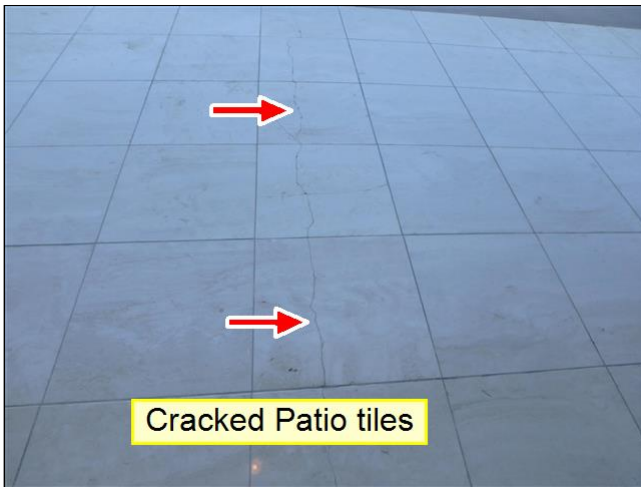
9.0 Item 1(Picture)

There are several cracked tiles on the Patio, Recommend repair for desired service.

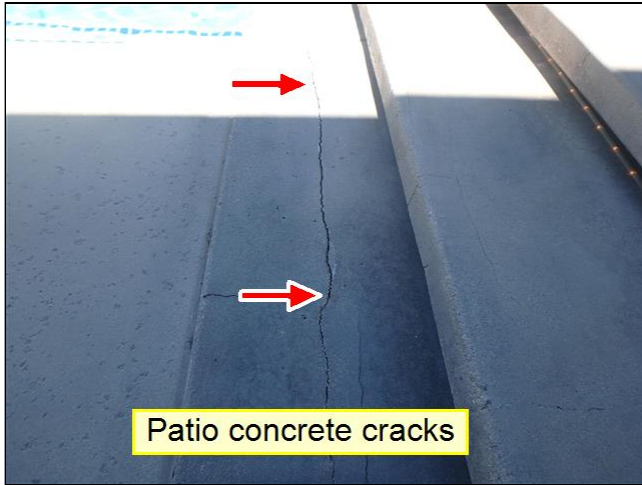
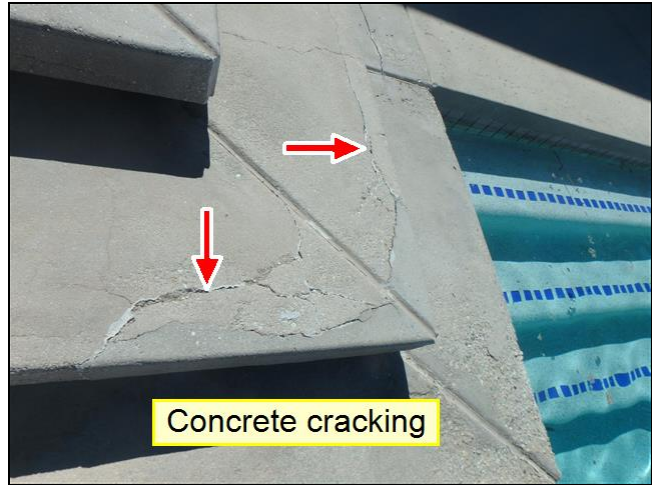
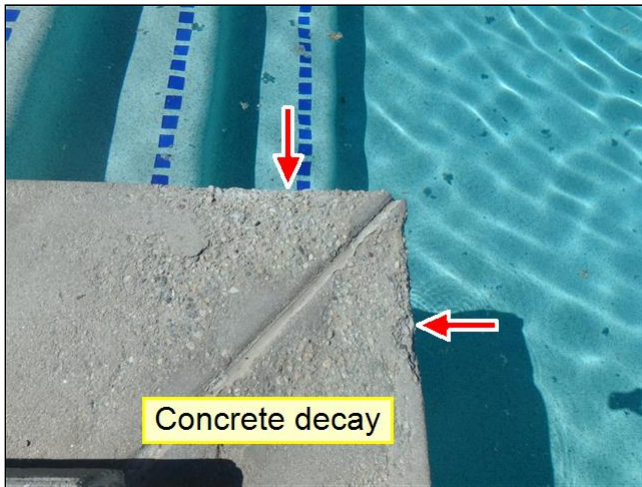
The Patio decks have cracking and decayed areas. Recommend further evaluation and repair for proper function.

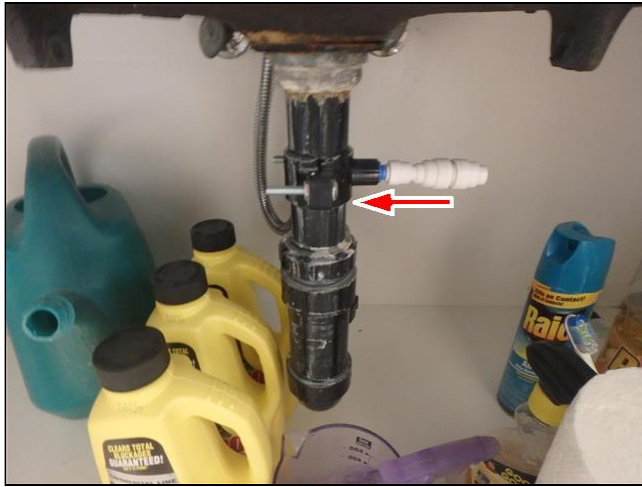
14.9 Item 1(Picture)

There is leak in the laundry basin plumbing under the sink. Recommend repair to prevent moisture damage.

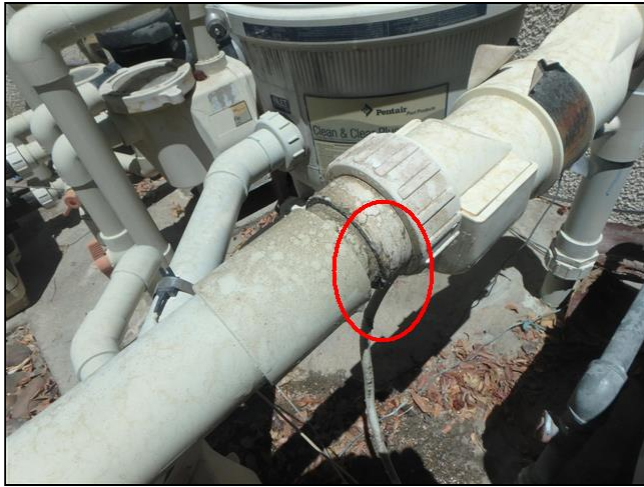
15.19 Item 1(Picture)

There is a leak at the Pool plumbing at the Salt turbo cell. Recommend repair for proper function.
